# TS 3-14 03313(R) MODIFICATION OF AUTOMATIC TRANSMISSION CONTROLLER Article Text

1992 Suzuki Swift For Xeon

# MODIFICATION OF AUTOMATIC TRANSMISSION (A/T) CONTROLLER

ulletin No. TS 3-14 03313(R)

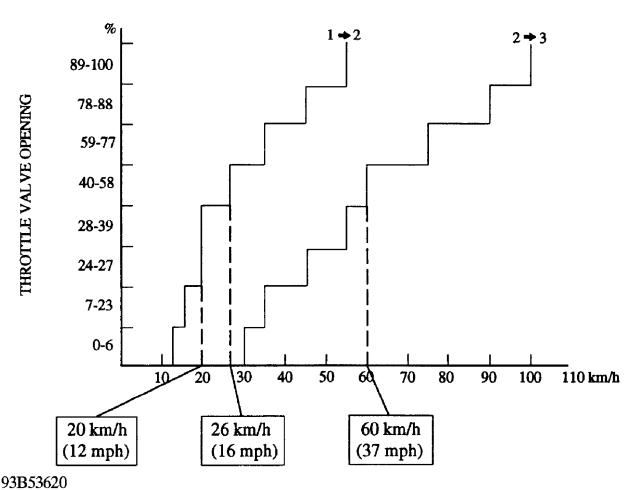
$93B53620 \\ \text{Fig. 2: Original A/T Shift Diagram}$

This bulletin is to inform you of the modification of the A/T controller which has been carried out since June 1992 production. Due to the modification of the AT controller, the A/T shift diagram has also been changed. See Figs. 1 and 2.
